# Manhole Inspection Summary

Manhole # S04AA2020MH

**Location** Address: **3801 WILLIAMSON AVE**

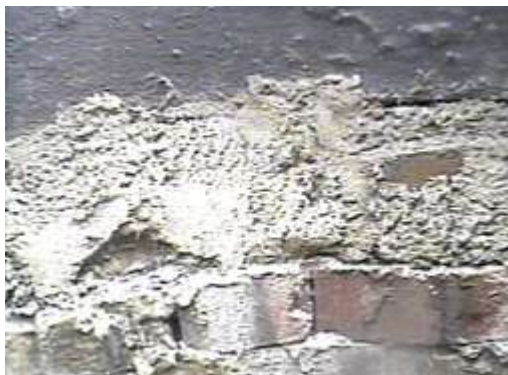
Defect

Comments **Cemititious debris on bench.**

Infiltration: ☐ None ☐ Joint ☐ Cracks ☐ Mortar ☐ Roots ☒ **Wall**

**Surcharge** ☒ **Evidence Of Surcharge** Depth: **1** (ft.) ☐ Active Surcharge Present

Corbel and Barrel infiltration. Evidence of surcharge - Bench debris.

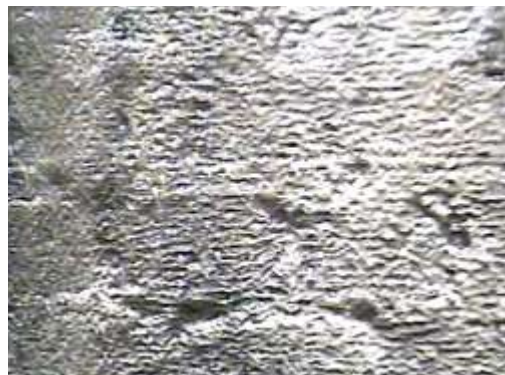
Defect

**Frame** Offset: **0** (in.) Condition: ☐ Sound ☐ Cracked ☒ **Leaks**

Condition: ☐ Sound ☐ Cracked ☐ Root Intrusion ☒ **Loose Brick** ☒ **Deteriorated**

Infiltration: ☐ None ☒ **Joint** ☐ Cracks ☒ **Mortar** ☐ Roots ☐ Wall

Frame leaks. Adjustment deterioration, loose brick and parging. Adjustment infiltration.

surcharge

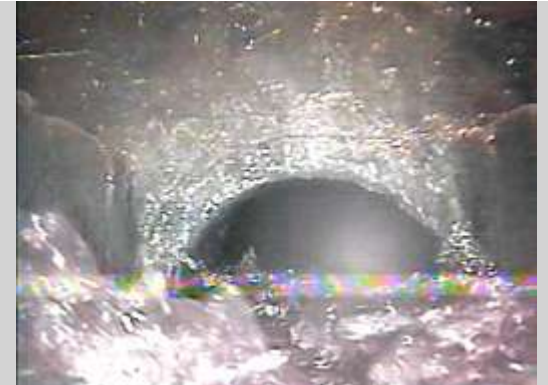
### 8 in. Circular Gravity Sewer Pipe Out @ 12 O'Clock

Rod and Bar (Angled)

Infiltration: **None** Pipe Seal Cond: **Unknown**

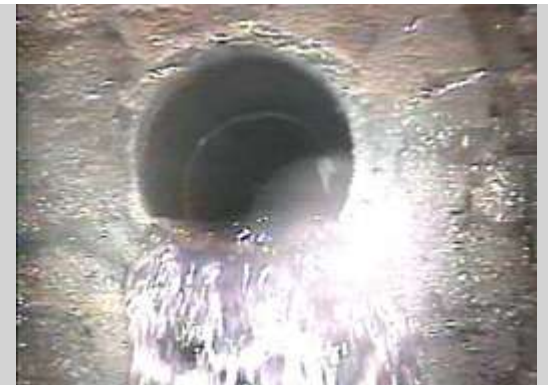
### 8 in. Circular Gravity Sewer Pipe In @ 3 O'Clock

Rod and Bar (Angled)

Infiltration: **None** Pipe Seal Cond: **Unknown**
